Manhole Inspection Summary

Manhole # S11MM1021MH

Insp Date: **12/6/06 11:37 AM**

Location Address: **3032 ROSALIND AVE**

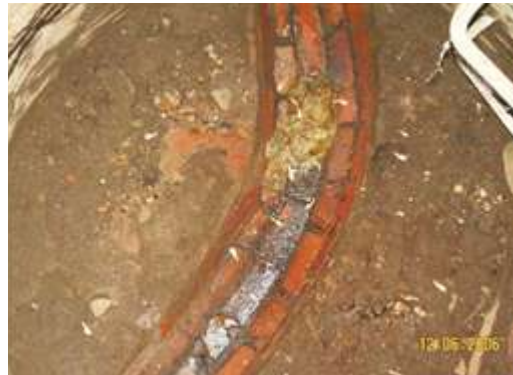
Top View

Evidence of surcharge - Bench debris.
Channel debris.

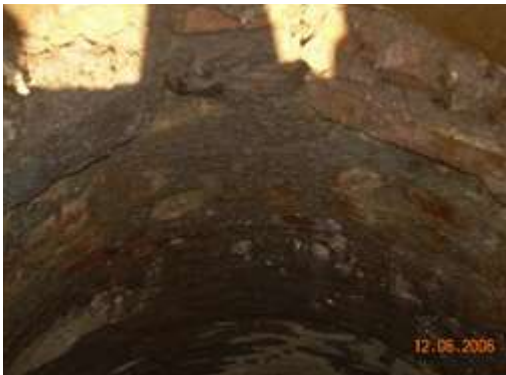
Defect

Frame Offset: **2** (in.) Condition: ☐ Sound ☐ Cracked ☒ **Leaks**

Condition: ☐ Sound ☐ Cracked ☐ Root Intrusion ☐ Loose Brick ☒ **Deteriorated**

Infiltration: ☐ None ☒ **Joint** ☐ Cracks ☒ **Mortar** ☐ Roots ☐ Wall

Infiltration: ☐ None ☐ Joint ☐ Cracks ☒ **Mortar** ☐ Roots ☒ **Wall**

Frame leaks. Adjustment deterioration
and infiltration. Barrel infiltration.

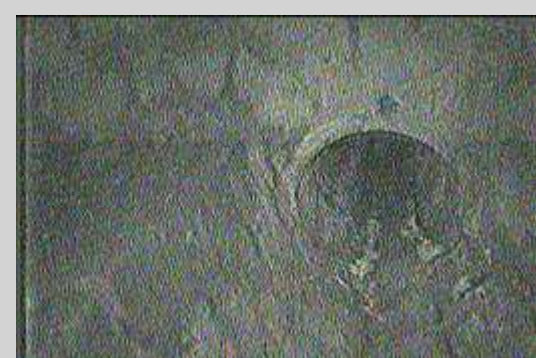
6 in. Circular Gravity Sewer Pipe In @ 7 O'Clock

Deposits: ☐ None ☐ Mud ☐ Sludge ☐ Debris ☒ Grease

Silt Depth: **0** (in.) Deposits Extent: **Light**

Infiltration: **Evidence** Pipe Seal Cond: **Unknown**
